Got Fire? Anticipate Collapse....

Christopher J. Naum, SFPE

Issued: November 9, 2011

A recent video clip making its way around the cyber fireground clearly depicted a very close-call and resulting near miss event to four firefighters at a four alarm fire involving a commercial building that housed an established insulation manufacturer and installation contractor.

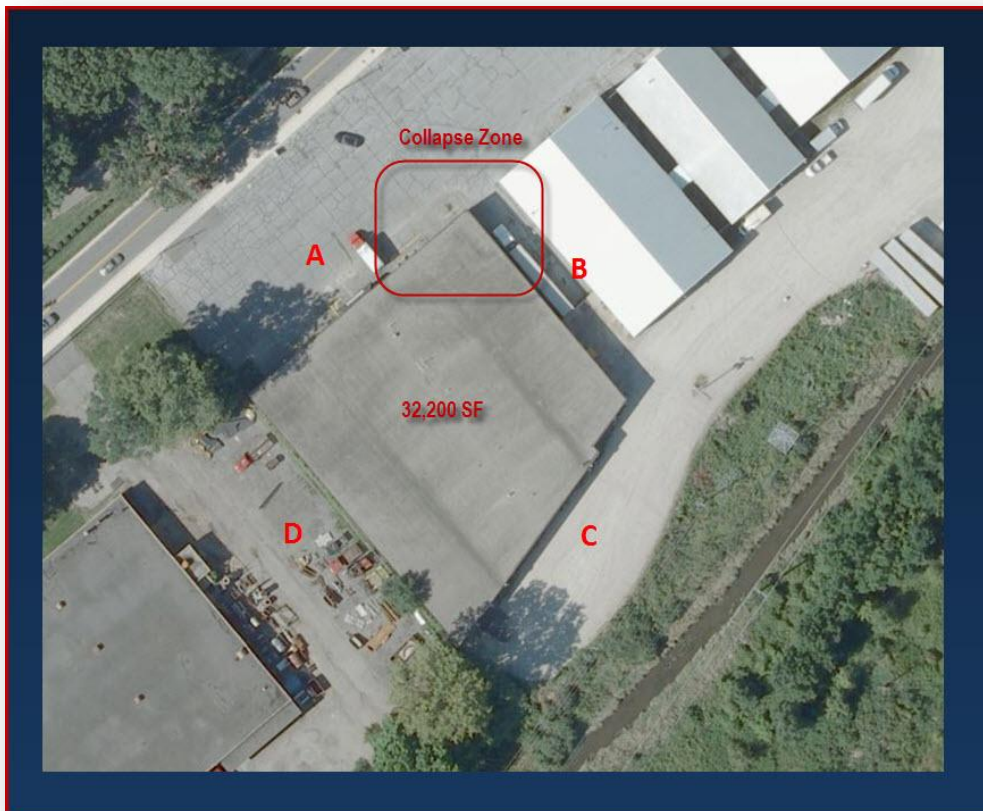
Aerial Plan of Building and Collapse Area A-B

The fire incident involved a single story commercial building occupying approximately 32, 200 square feet of area on a multiple building site with proximal exposures. Manufacturing, warehousing and offices comprised the building's operational use. An aerial plan view shows the geographical building scene divisions and the location and relationship of the Alpha- Bravo Side collapse zones that affected operations and resulted in the close-call and firefighter near-miss. The proximity of exposures, physical layout and orientation can be further assessed.

- Manufacturing Occupancy
- 32,200 SF
- Circa 1965
- Non-Combustible Construction
 - Unprotected Steel Bar Joists
 - Steel Column and Beam Structural Supports
 - Concrete Masonry Units (CMU) Wall Envelope
- 4 Alarm Fire
- Transitioned to Defensive Operations
- Elevated Master stream Operation
- Alpha Division, numerous large door openings
- Collapse A-B corner
- Four Firefighter Near-Misses

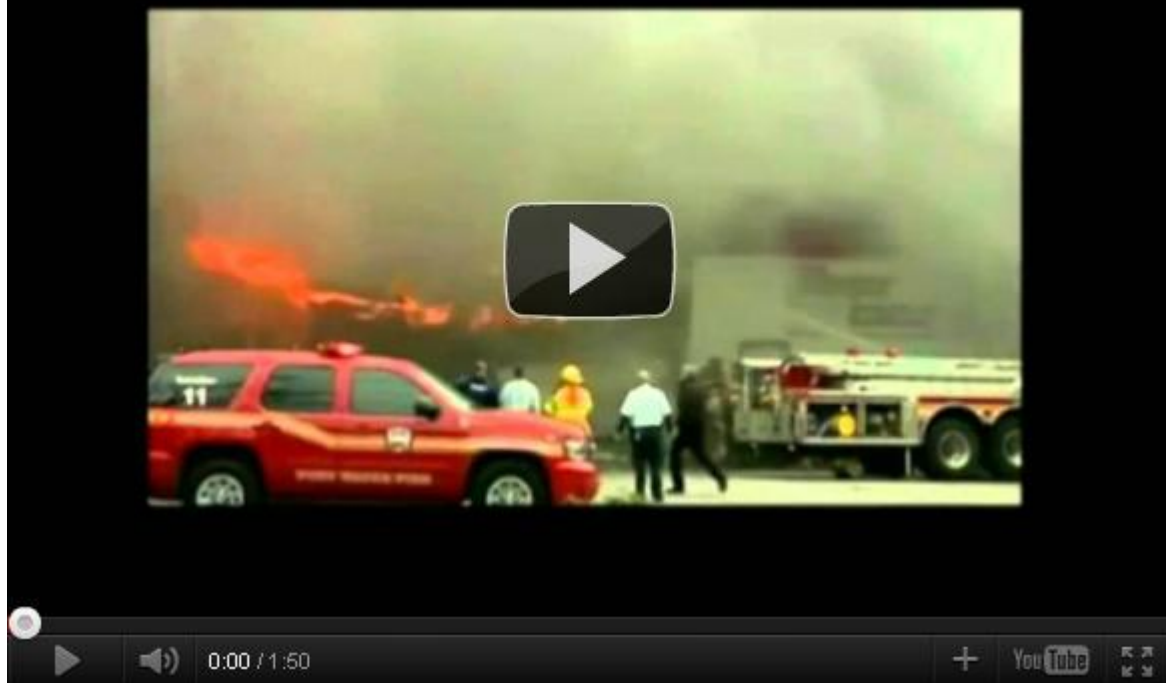
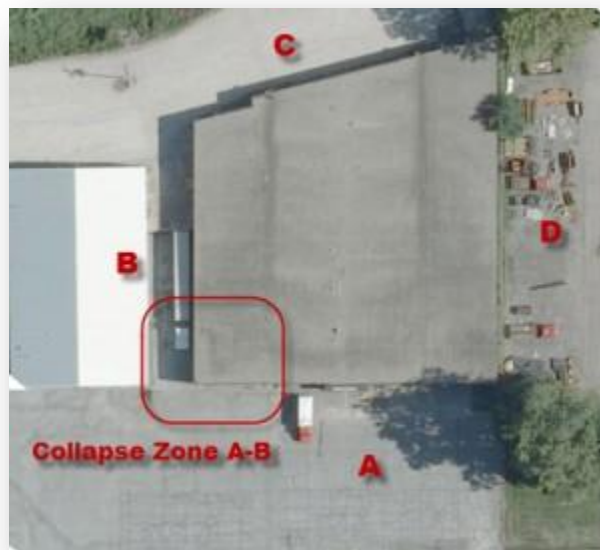
Aerial Overhead view of the building perimeter walls along the four divisions (A-D) with the A-B corner that subsequently experienced the wall-roof compromise and resulting collapse.

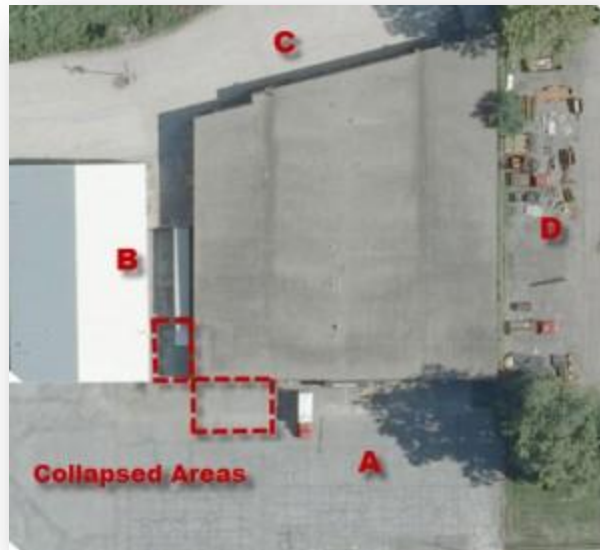
The A-B corner and the affected ground areas around the collapse zone. Considerations for a collapse zone area on the A-B corner would have resulted in a minimum distance of twenty five (25) feet from the building base for all operations within this area. The collapse zone on the Bravo side extends into the exposure building due to its close proximity.

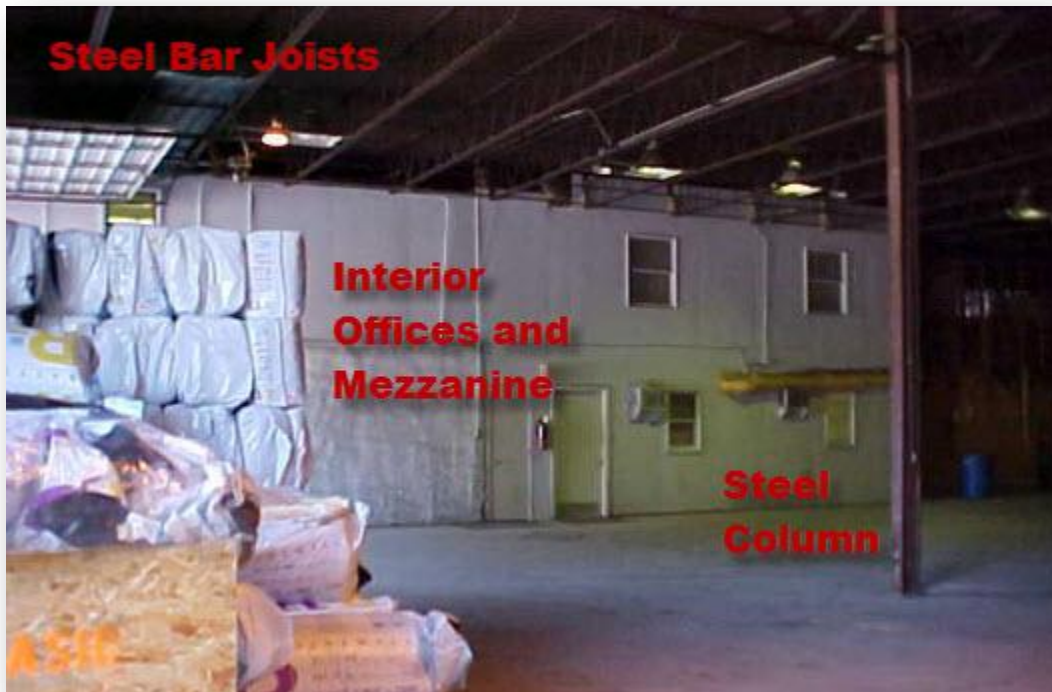
Typical Interior

The interior of the building included unprotected steel components and assemblies consisting of steel columns, beams and open web steel joists. These common and conventional structural support systems provided large free clear spans, common for typical warehouse and commercial occupancies.

The presence of unprotected steel components (Truss, column, structural beams etc.) and assemblies requires an understanding of the effects of flame and heat impingement, rate of heat release and fire dynamics, potential for movement and displacement of structural components and effect on assemblies, systems and connections and the effect on structural stability, integrity and building load transfers and displacement that all can adversely affect building performance, integrity and collapse potential

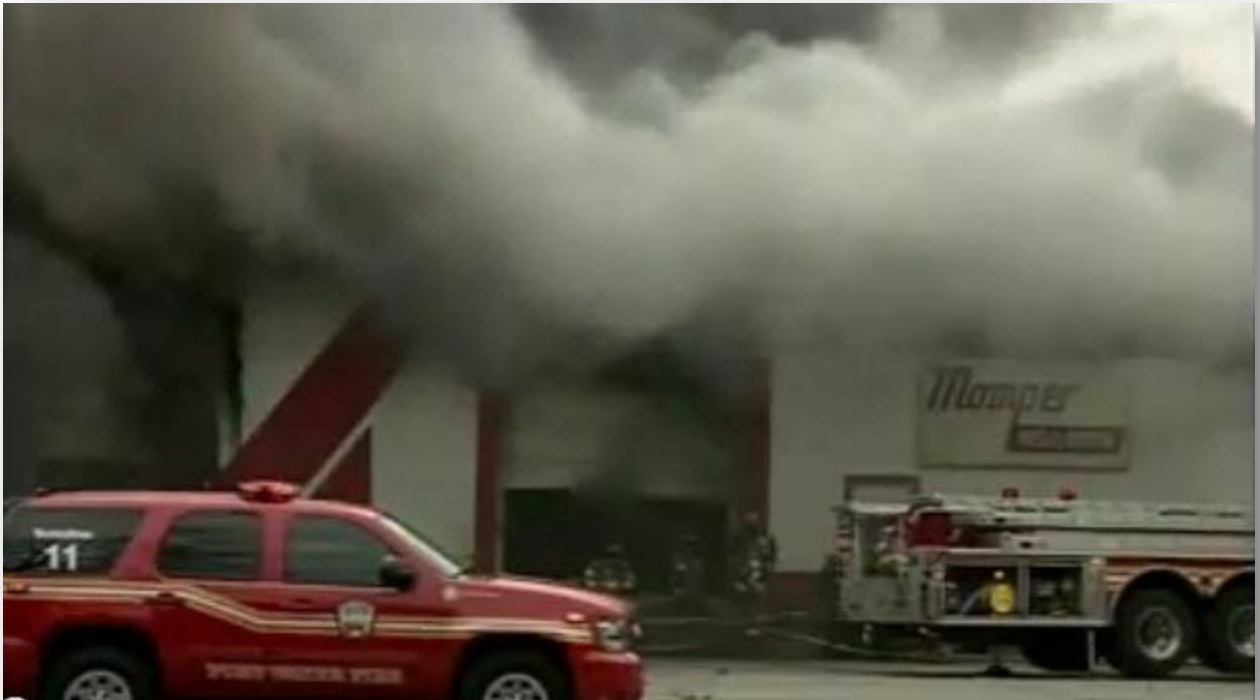
Pre-Collapse Operations on Alpha side with personnel in close proximity to the building perimeter

Pre-Collapse view of Operations on the Alpha side with personnel in close proximity, (within [a] collapse zone) to the building perimeter. It is evident that the degree of interior fire extension and involvement presumes a cautious deployment and placement of personnel in safe operational areas. When operating in such close proximity to the building wall and envelope, it becomes increasingly challenging for company officers and company personnel to monitor overall building performance indicators that may be prevalent or dominant from a view point further away from the building.

Fire extension, smoke conditions, component or assembly movement or displacement may be readily defined and identified from a vantage point away from the building, requiring additional independent operational assignments within the division if resources allow. Otherwise, officers are encouraged to get a big picture view and increase their span of vision of the building and progressing fire conditions and building performance

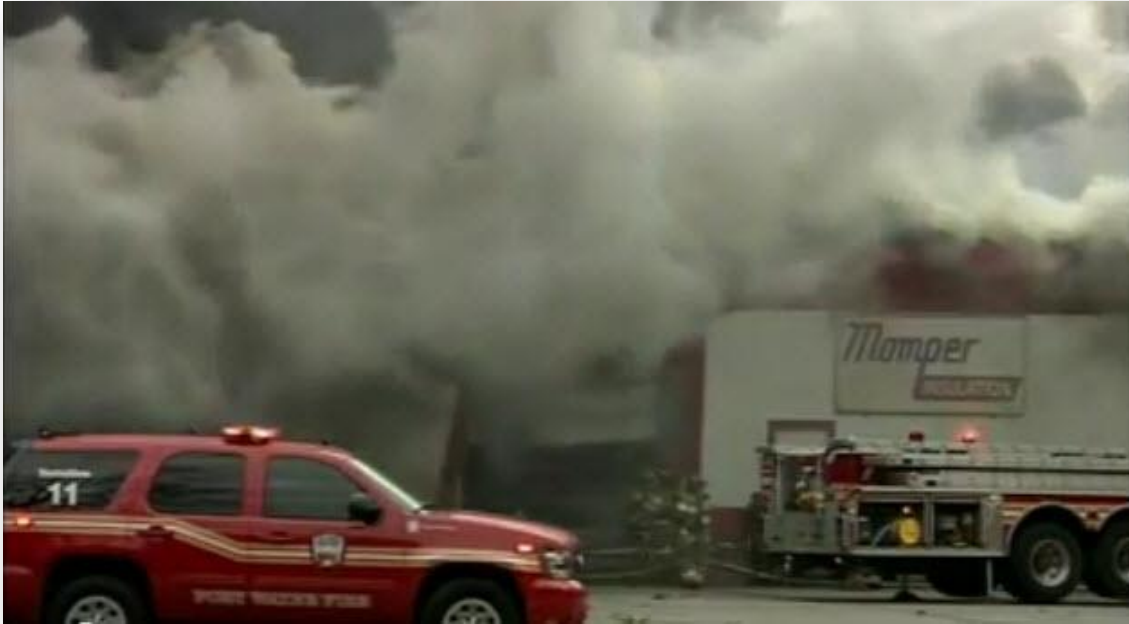
Image 04

Frame image 04 depicts the rapidly deteriorating conditions that are evident as the collapse sequence continues and the overhead door jamb (left) buckling and adjacent wall failing by way of an outward curl or peel away commencing from the upper (left image) A-B corner at the roof line and then peeling and failing from upper left to right.

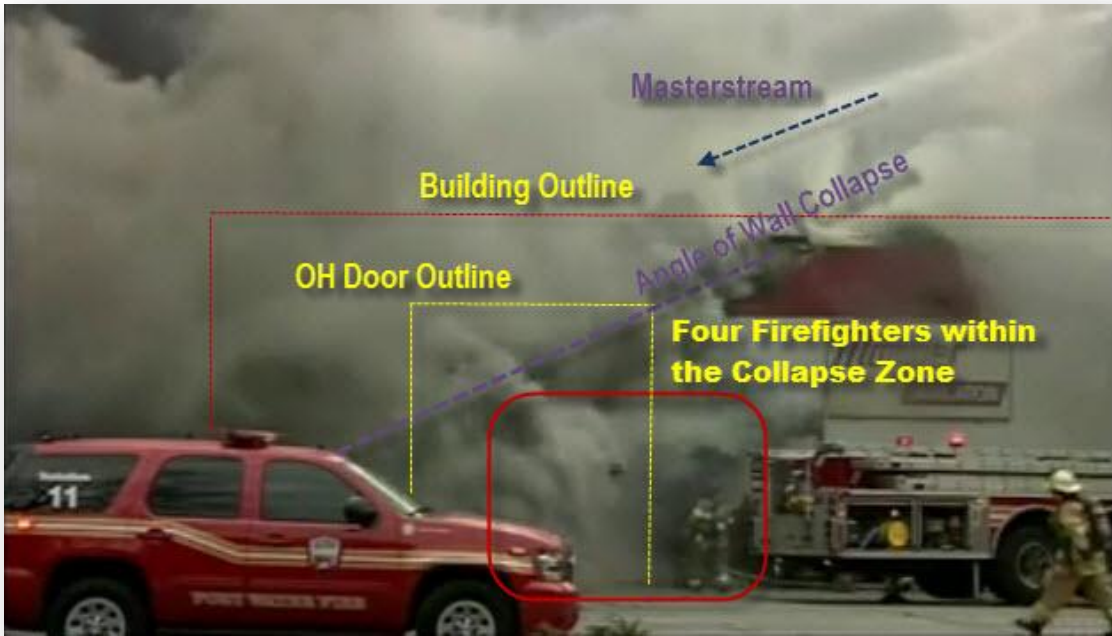
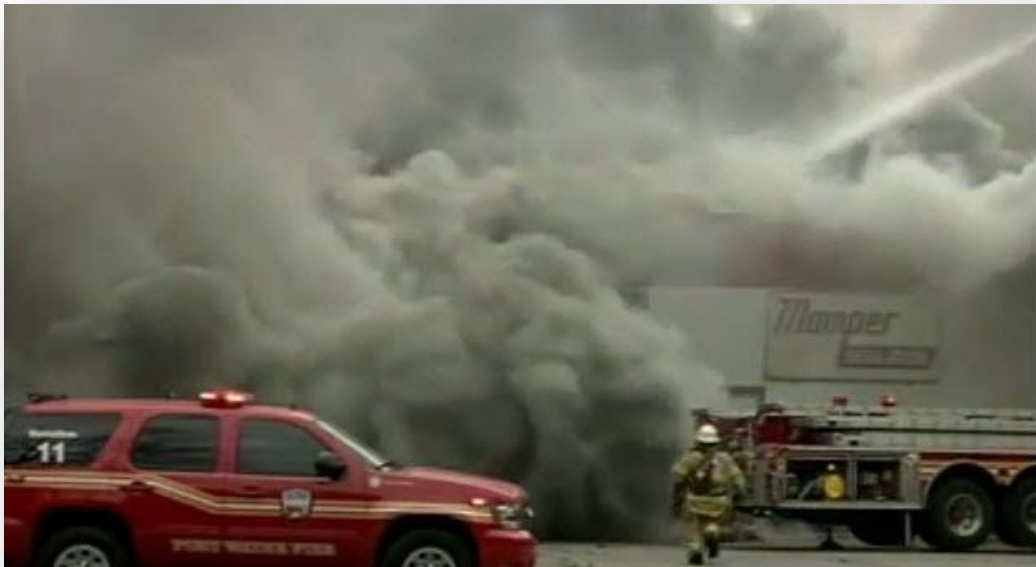
The remaining images, frames 06 and 07 depict the location of the firefighters to the wall collapse, the relationship to the wall and roof system and the degree of wall area that became compromised and collapsed.
