Got Fire? Anticipate Collapse....

Christopher J. Naum, SFPE

Issued: November 9, 2011

A recent video clip making its way around the cyber fireground clearly depicted a very close-call and resulting near miss event to four firefighters at a four alarm fire involving a commercial building that housed an established insulation manufacturer and installation contractor.

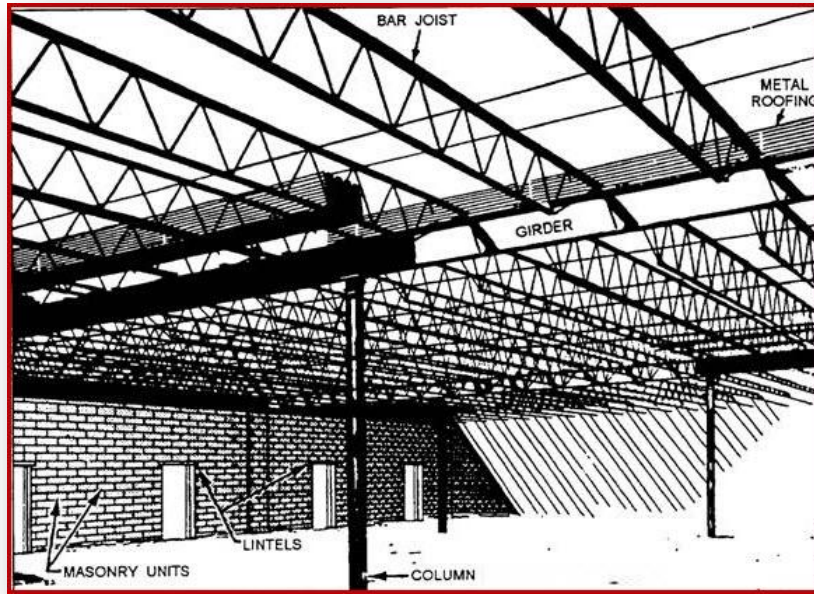
The presence of unprotected steel components (Truss, column, structural beams etc.) and assemblies requires an understanding of the effects of flame and heat impingement, rate of heat release and fire dynamics, potential for movement and displacement of structural components and effect on assemblies, systems and connections and the effect on structural stability, integrity and building load transfers and displacement that all can adversely affect building performance, integrity and collapse potential

Typical Structural System and Components

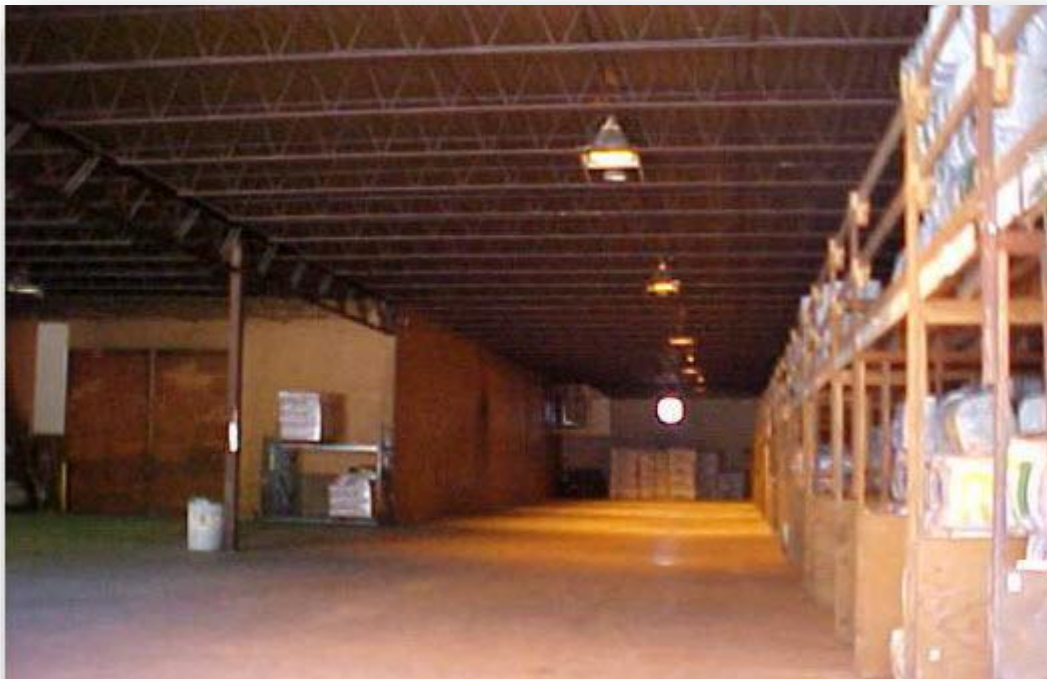
Interior View with Steel Columns, Open Web Steel bar Joists and Beams
